Broad Top AMD "Superheroes"

EPA and PADEP recently met with Broad Top Township officials and toured numerous abandoned mine drainage (AMD) treatment projects in the Township.

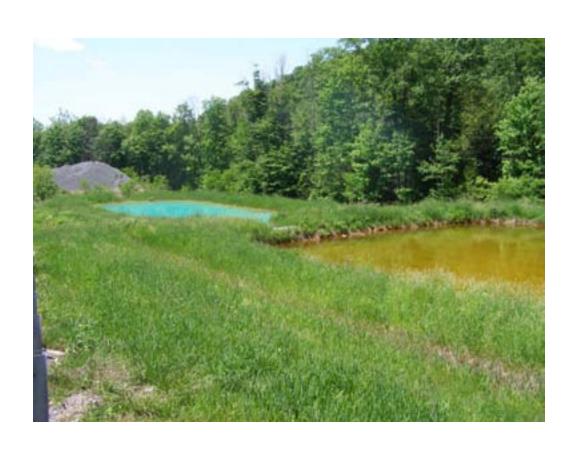
Treatment Ponds for AMD Discharge SX0-D4 on Six Mile Run

Broad Top Township obtained funding from state and federal sources, including over \$900,000 from Section 319, to address soil erosion and water pollution.

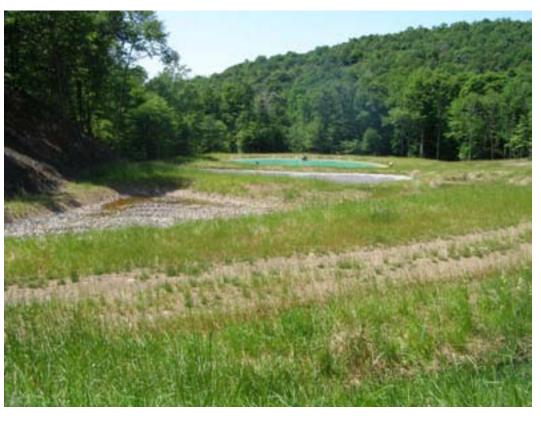
Township Track Hoe Constructing Pond to Treat SX2-D5 Discharge

The Township has used their own employees and equipment to cost effectively construct a total of over 28 AMD passive treatment systems in the Six Mile Run, and Sandy/Longs Run Watersheds.

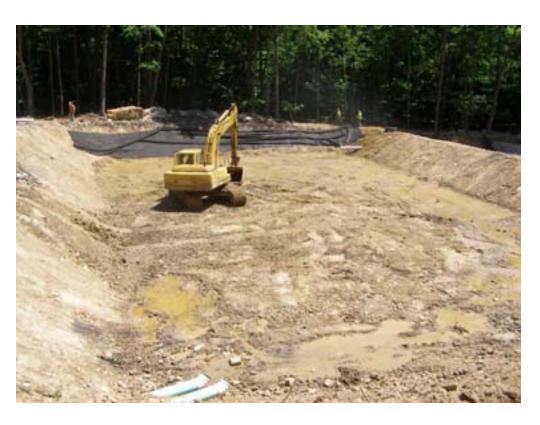
Seep LR0-D13 a Deep Mine Opening Tapped for Treatment

Rock and overburden was carefully removed from a collapsed deep mine opening so a structure could be constructed to tap the flow and control it for treatment.

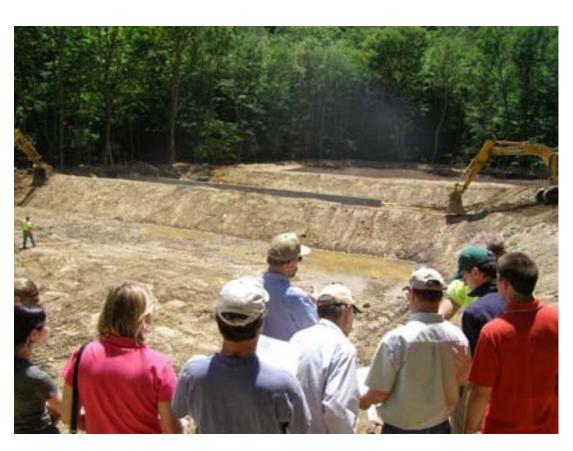
Township Employees Maintain What They Build

Broad Top builds with an eye to the future knowing that they will also be operating and maintaining these systems. Employees and equipment are available for routine and other service.

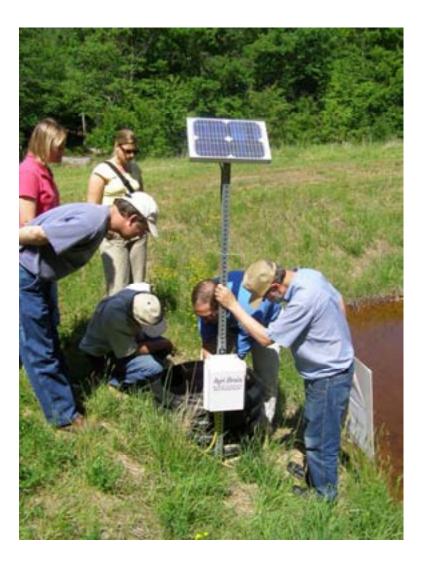
A solar powered back flush valve was installed for the pond treating seep LR0-D10.

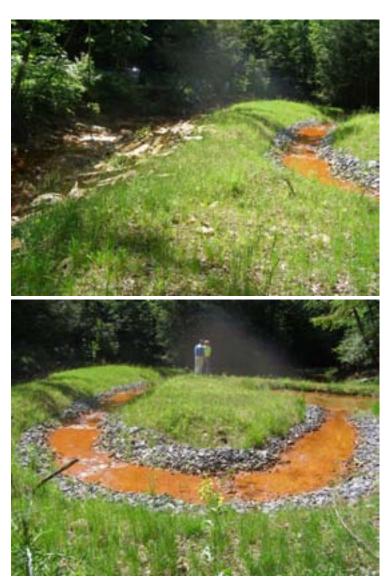
The treatment system for the LR0-D14-seep on Longs Run is in a tight valley with the stream on one side and an embankment on the other. Access and having the footprint needed for treatment is a challenge at many of the remaining seeps.
